EXHIBIT 5 (PART 2 OF 2)

2.5.3 Cabinet Interior

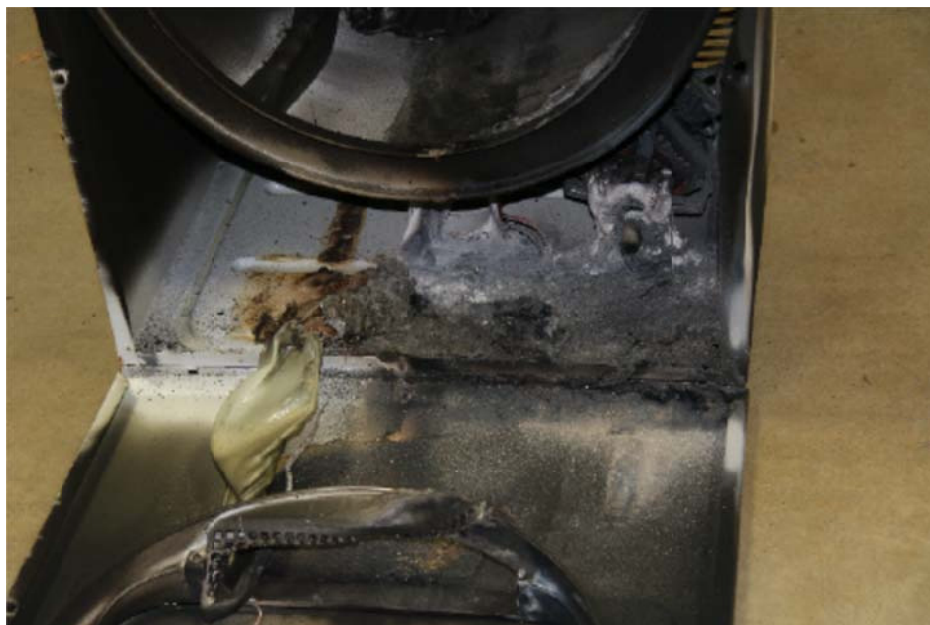
Image 306 from "Burn Test 01_10-31-2013.pdf"

Figure 32. Blower assembly and air duct are melted and burned with more damage toward the right side similar to fire damage patterns observed in past burned Electrolux dryers.

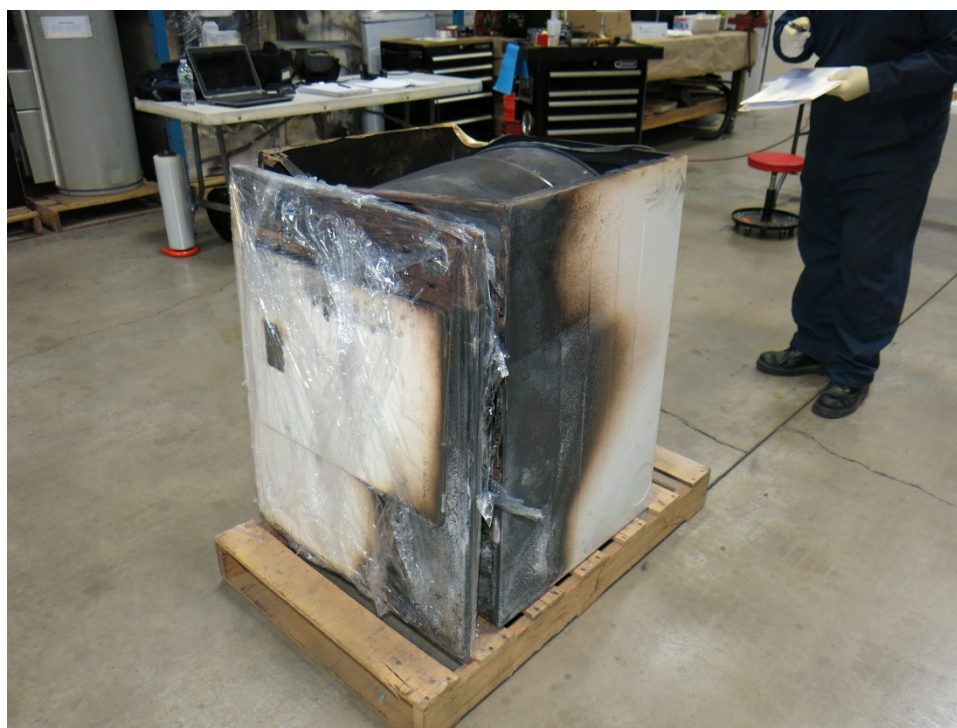
D14813-0039

Figure 40. Photograph of 2005 Electrolux-manufactured and GE-branded clothes dryer that was involved in a fire.
